Manhole Inspection Summary

Manhole # S33A__029MH

Insp Date: **9/22/09 3:41 PM**

Location Address: **606 CATHEDRAL ST** Cross Street: **MT VERNON PL**

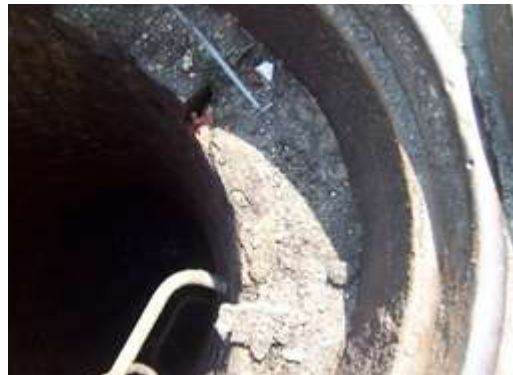
Defect 1

Frame Offset: **3** (in.) Condition: ☒ Sound ☐ Cracked ☐ Leaks

6" OFF SET FRAME

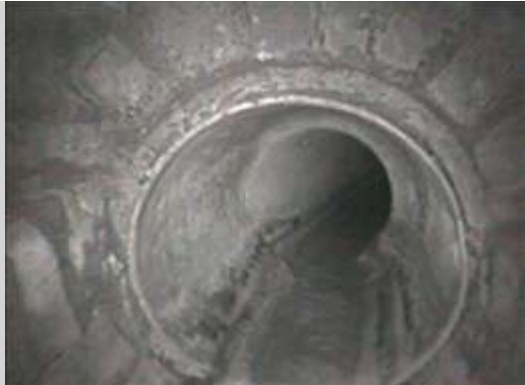
12 O'Clock Outflow

10 in. Circular Gravity Sewer
Pipe Out @ 12 O'Clock

Invert Depth: **12.50** (ft.) Flow Characteristics: **Fast**

Infiltration: **None** Pipe Seal Cond: **Sound**

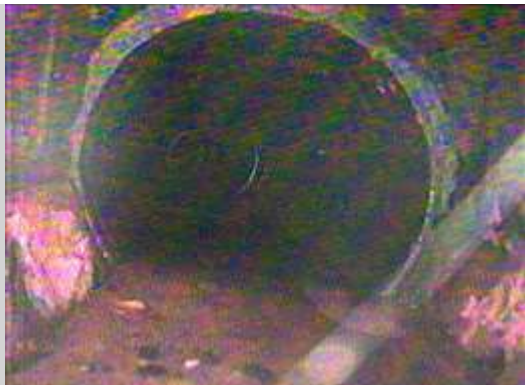
3 O'Clock Inflow

10 in. Circular Gravity Sewer
Pipe In @ 3 O'Clock

Invert Depth: **12.48** (ft.) Flow Characteristics: **Fast**

Infiltration: **None** Pipe Seal Cond: **Sound**

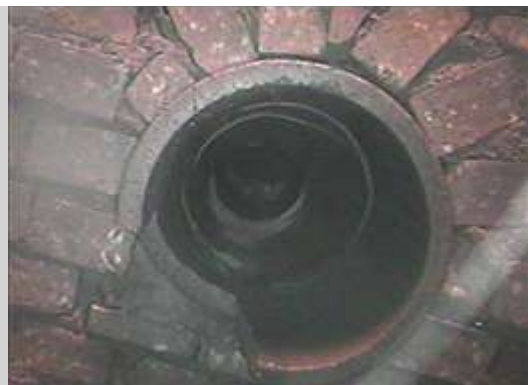
9 O'Clock Inflow

10 in. Circular Gravity Sewer
Pipe In @ 9 O'Clock

Invert Depth: **9.30** (ft.) Flow Characteristics: **Fast**

Infiltration: **None** Pipe Seal Cond: **Sound**

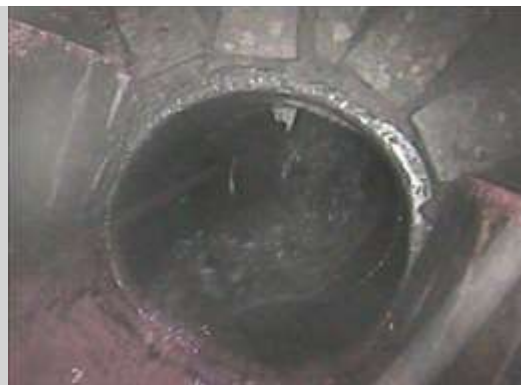
Drop In @ 9 O'Clock

Drop: **Outside** **Direct**

Inv Depth: **12.54** (ft.)

Drop Condition: **Open**
